John Hollings Seismic Resilience in Practice Award - Submission

Project: **Te Whare o Rehua Sarjeant Gallery – Seismic Strengthening**
Location: **Pukenamu, Queens Park, Whanganui.**
Architect: **Warren & Mahoney Architects (Warren and Mahoney)**
Engineer: **Clendon Burns & Park Consulting Engineers, Wellington**
Client: **Whanganui District Council**
Contractor: **McMillan Lockwood, Palmerston North**
Completion: **July 2024**
Opening: **9 November 2024**

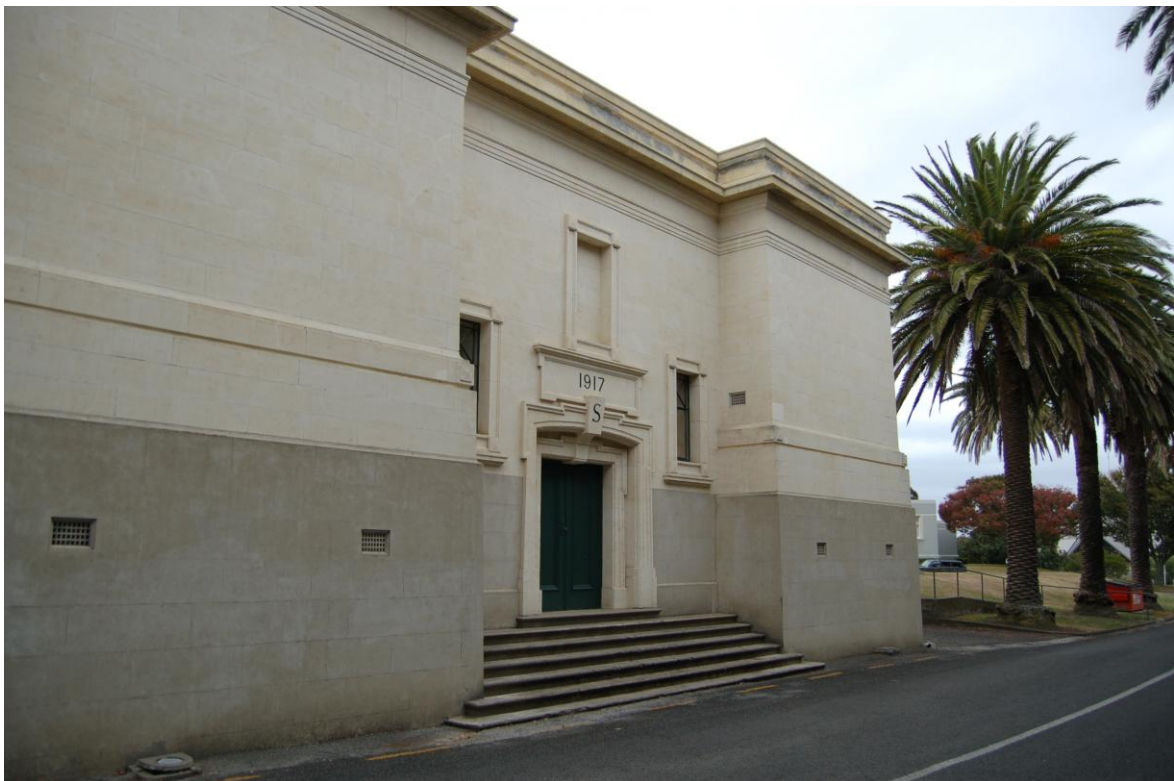
Figure 2: Northern Elevation: Entrance at basement or road level (closed in 2014)
(This entrance was lifted in the redevelopment to be at the gallery level,
with the architectural features retained and a new link bridge
installed connecting the old and the new buildings)

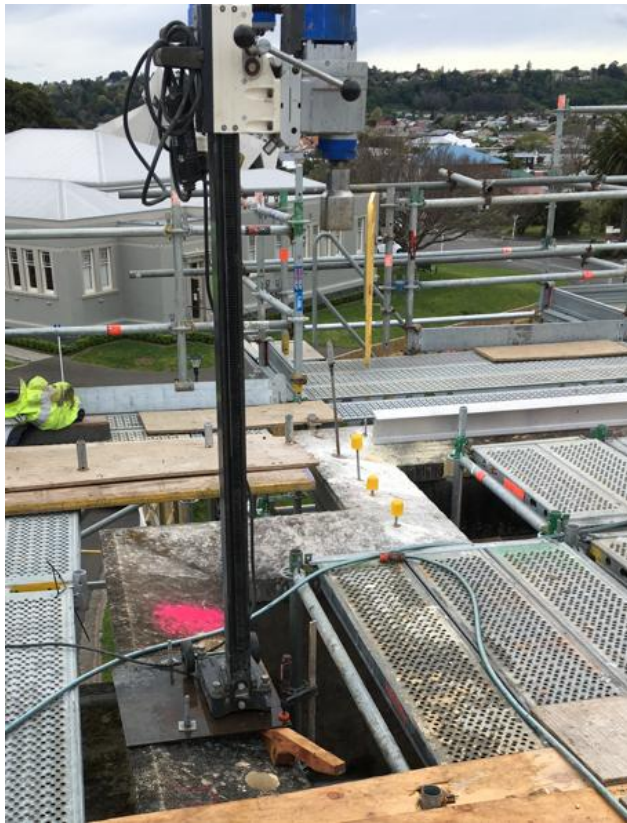
Figure 1.7 Drilling of holes for a prestress bar at roof parapet.

Over 300 stainless steel prestressing bars, up to 12 meters long were installed within vertical holes drilled in the walls with the bars anchored in the new reinforced concrete capping beams at the roof level and embedded in the existing concrete foundations. The bars were grouted in place and stressed to the design load.

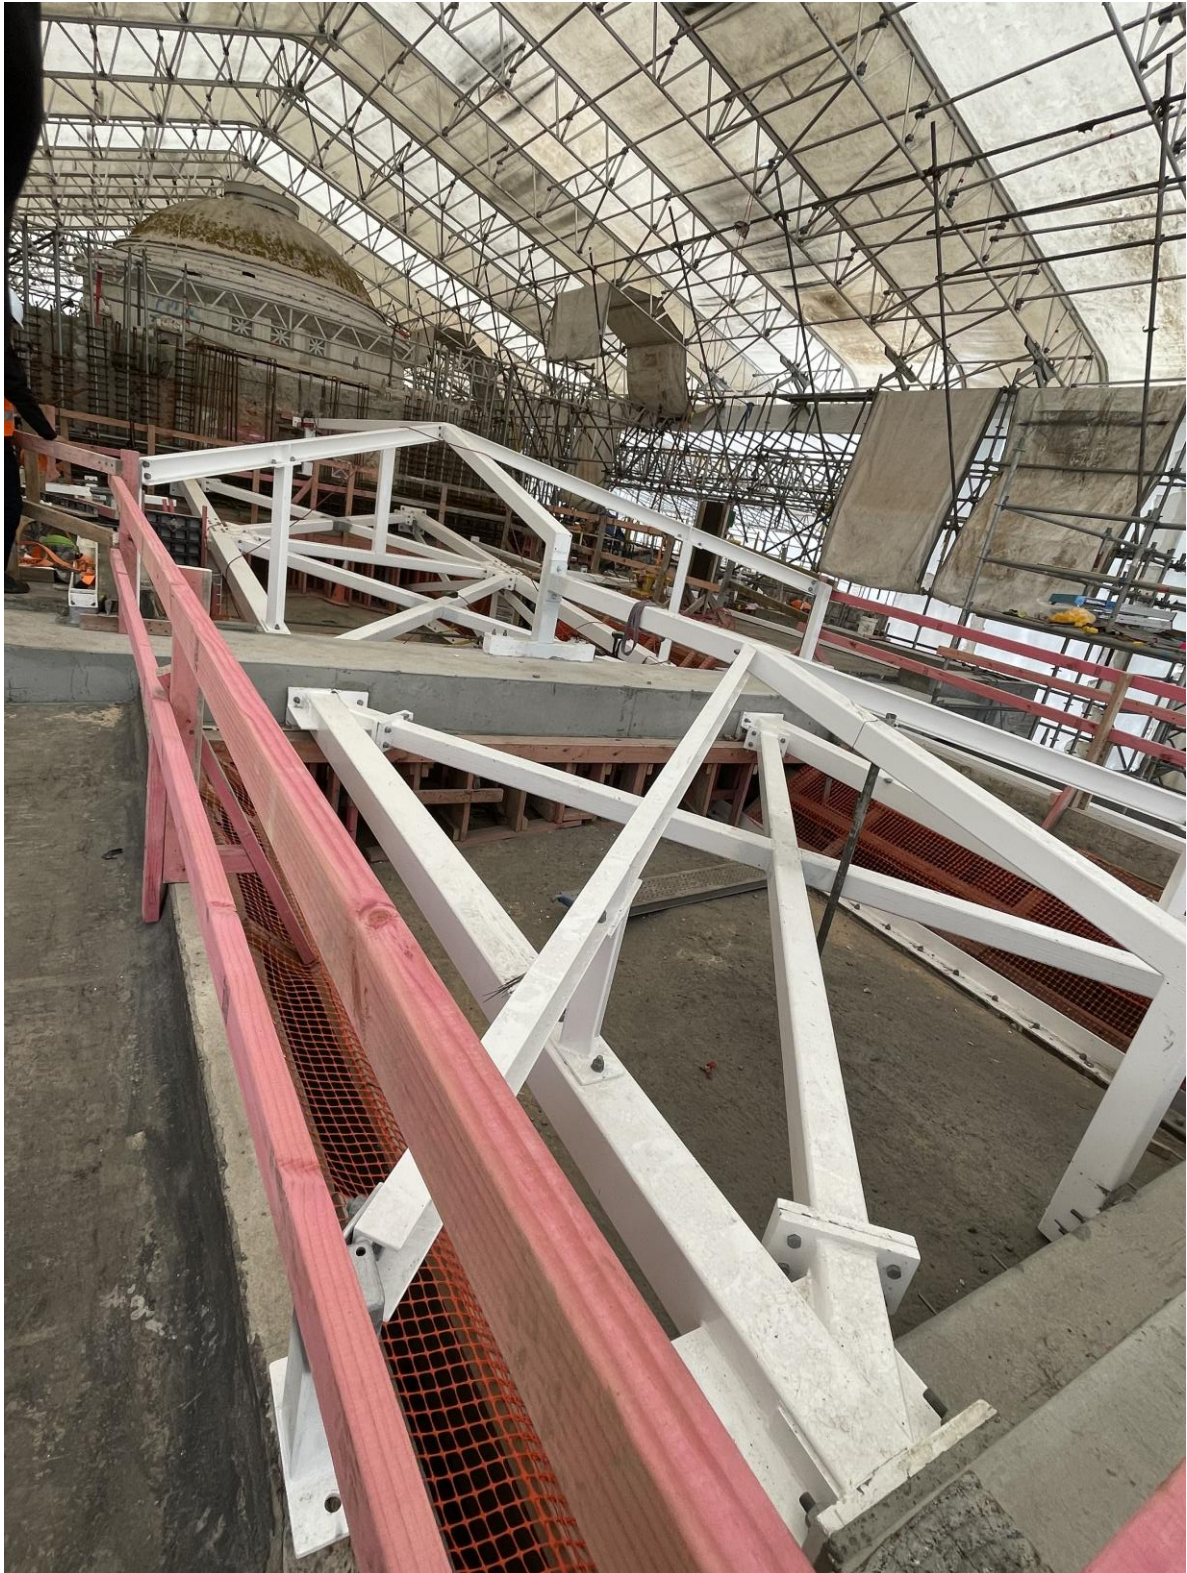
Figure 1.9 Roof steelwork and steel truss bracings over West Wing.

At the roof level, steel truss bracings combined with roof level capping beams tie the walls together for the in-plane and out of plane seismic loading. At the central dome area and the central core, a combination of carbon fibre, reinforced concrete coupling beams and prestressing were used.

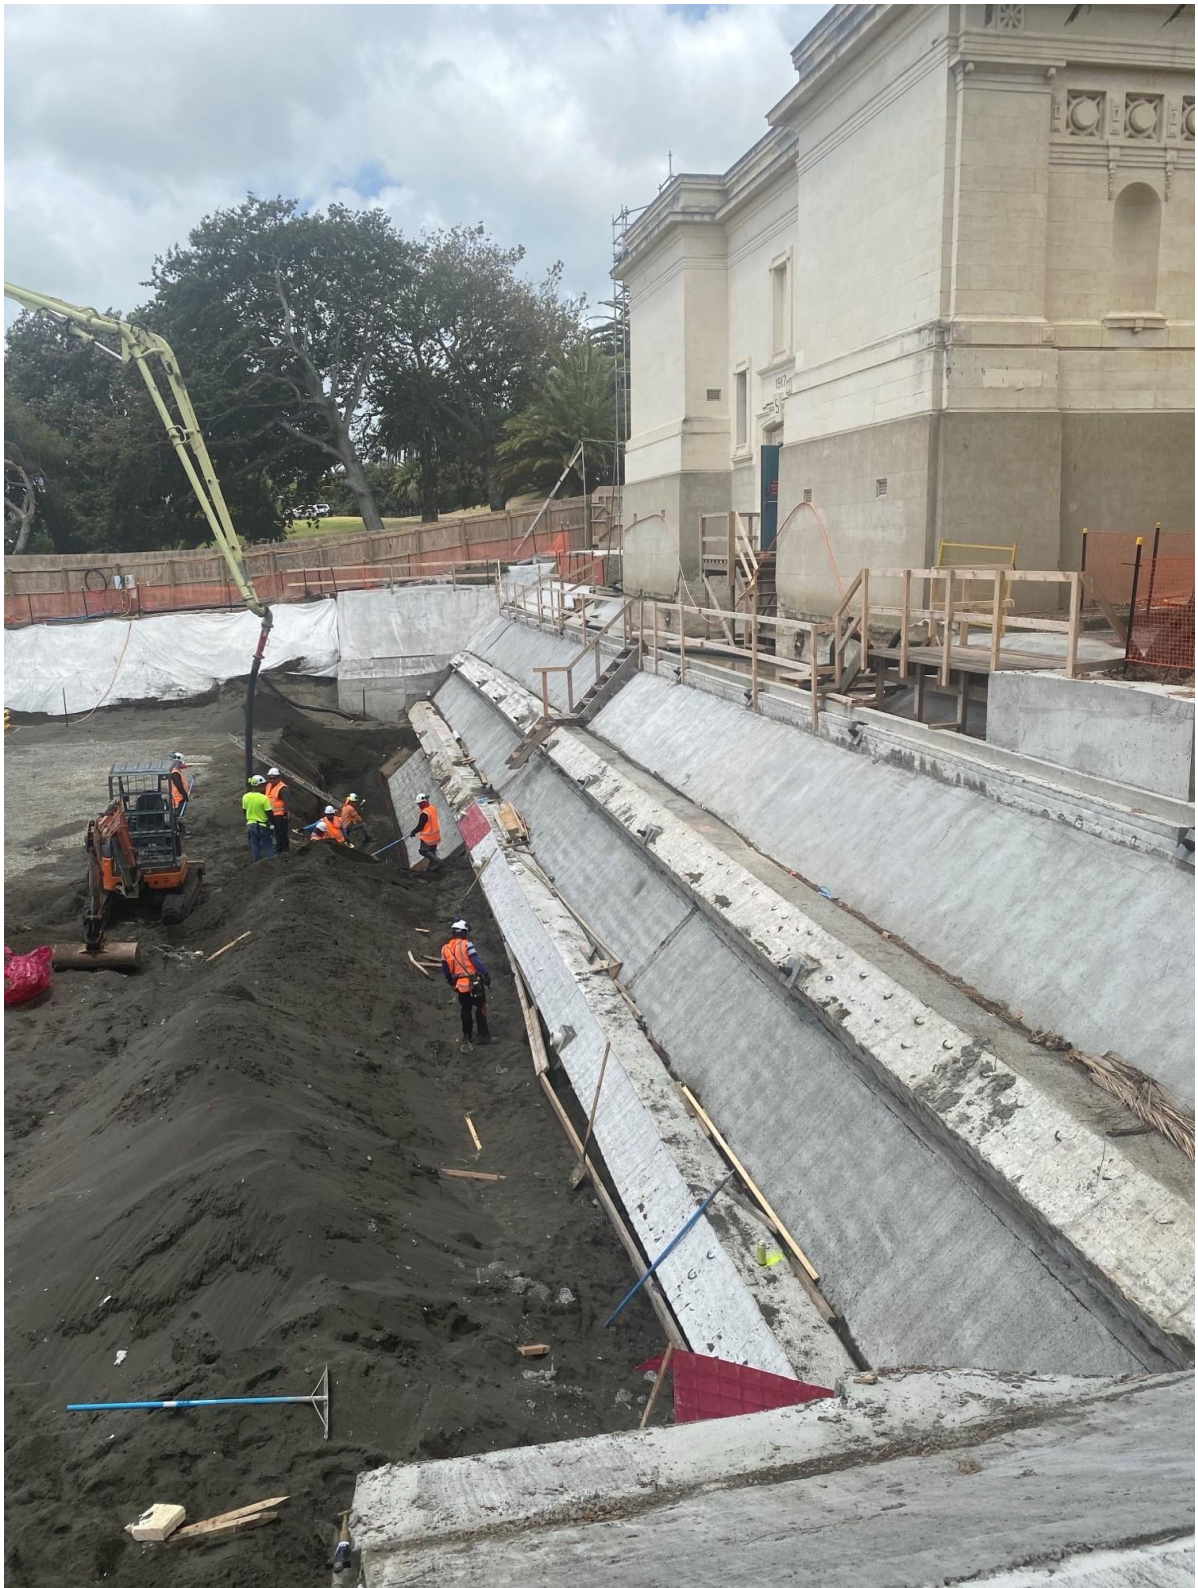
On the north side of the Sarjeant Gallery, excavation was required to a depth of approximately 4.5m to construct the basement for the new extension building. Due to the relatively high gravity bearing loads on the perimeter wall and the strip footings being supported on existing sandy ground, particular care was taken to prevent collapse of the building into the excavation and potential excessive settlement causing damage to the existing building.

Figure 1.10 Temporary retaining wall at the north side of the original Sarjeant Gallery building nearly completed to accommodate the basement of the new extension building.

Through discussions with IRBA, temporary staged excavation support was developed which involved a reinforced concrete apron, Titan Ischebeck anchors and regular monitoring was carried to detect any potential movement of the building. The excavation and supporting apron

were undertaken in three vertical and five horizontal stages to help manage risk. Refer Figure 1.10 for a photo of the excavation and the temporary retaining wall.

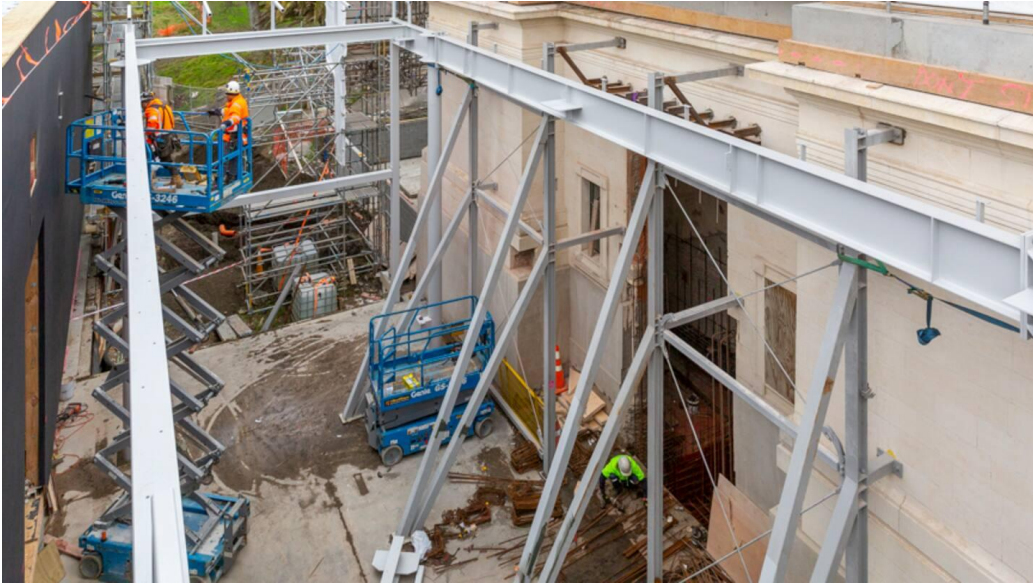
Figure 1.11 Temporary steel work to stabilise the north façade to allow relocation of the north entrance from the basement level to the gallery level and to allow a bridge structure to be installed. (Refer Figure 2 and Figure 1.10 for the original north entrance location)

The Warren and Mahoney design has a link that connects the original Sarjeant Gallery to the new extension at the first floor Gallery Level at its north side. The link is a steel bridge that spans between the original and the new building, requiring the entrance to be lifted to a new elevation. To allow the existing entrance with the North Wall features to be retained and lifted to the new elevation, required meticulous planning of the temporary works and careful construction sequencing of the permanent works. Refer Figure 1.11 and Figure 1.12.

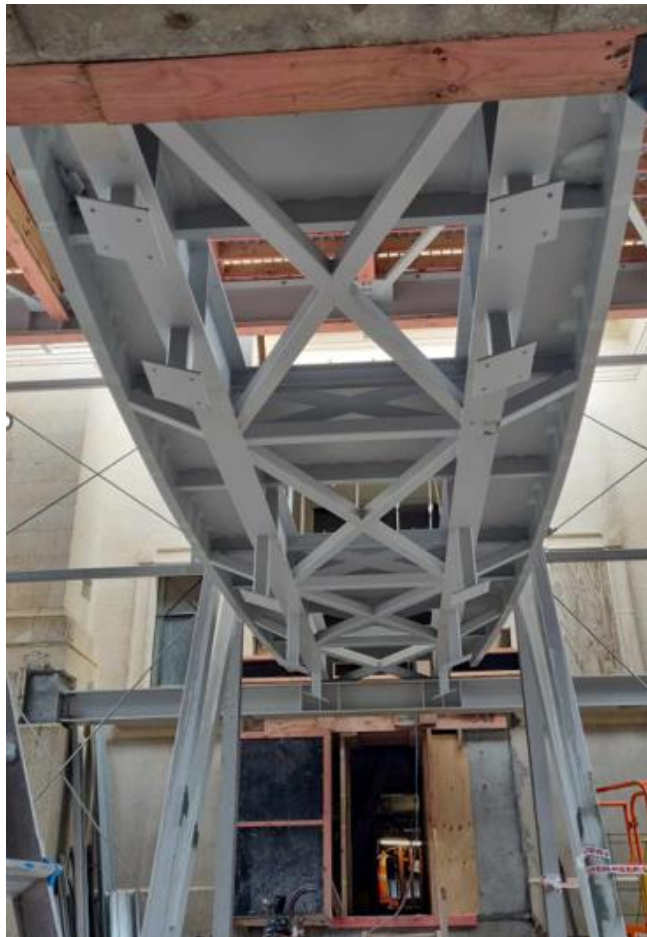
Figure 1.12 Bridge structure being installed amongst the temporary works at the north façade prior to being cladded in Maori carving.

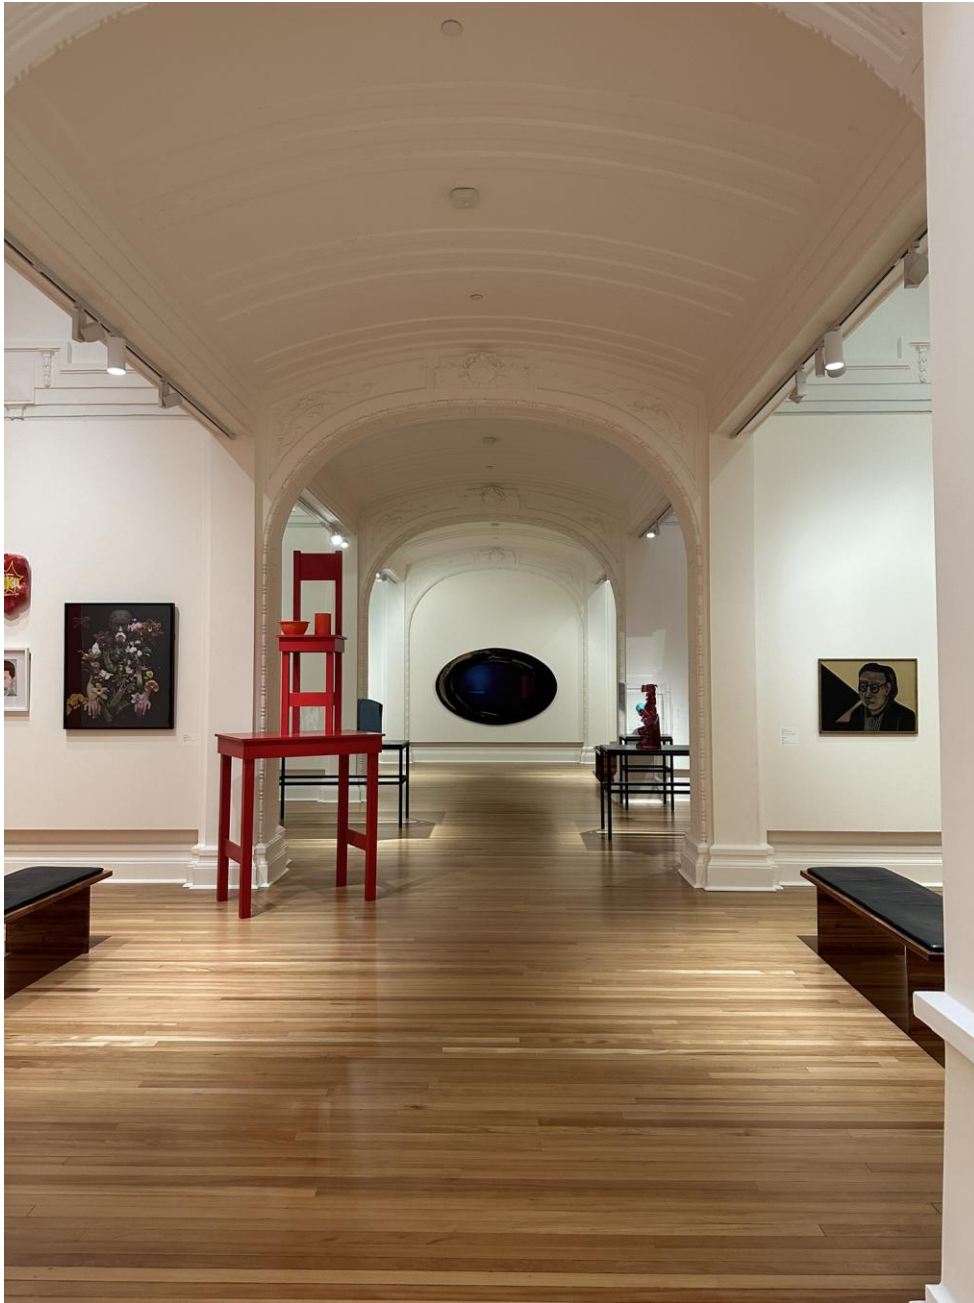
Figure 2.5 View of the interior with the original timber floor boards reinstated and laid over the new concrete floor.

The existing timber floorboards were lifted and stored to be reused, the timber floor joists and the brick arches were removed. A new composite floor, formed by casting concrete on metal decking supported on steel beams, was installed over the entire footprint of the building. The re-cycled timber boards were laid over the new concrete floor to reinstate the original interior architectural feel of the building, while providing a vital structural function of providing an effective structural diaphragm.
